**SENSING TECHNOLOGY FOR DAMAGE ASSESSMENT OF SIGN SUPPORT
STRUCTURES**

Master of Science in Civil Engineering

University of Pittsburgh

STRUCTURAL HEALTH MONITORING OF HIGHWAY SIGN SUPPORT STRUCTURES

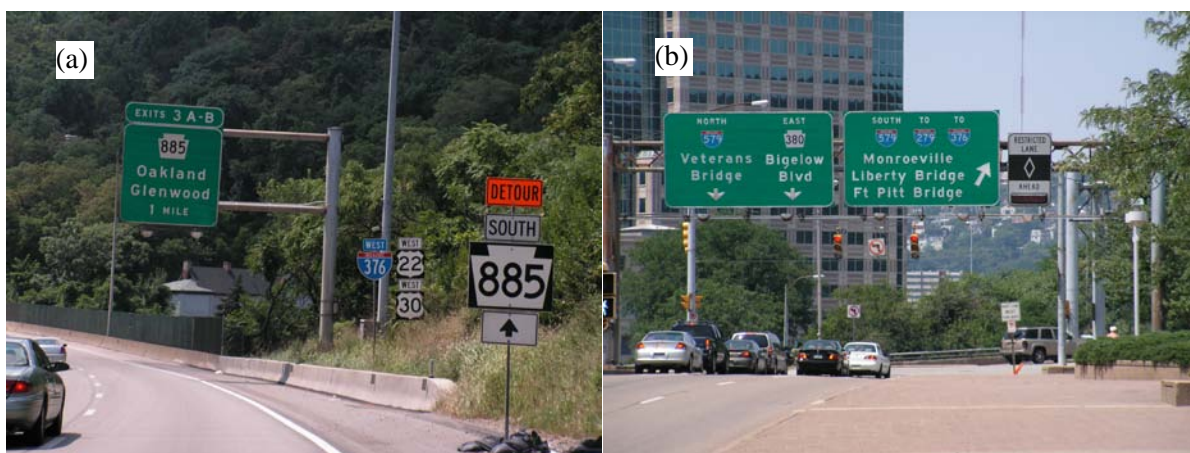
Figure 1.1 – Main sign support structure types used in Pennsylvania.(a) overhead cantilever with single pole; (b) overhead bridge truss with truss poles.

Overhead cantilever signs consist of a mast arm extending out over the roadway supported by a single roadside column, typically a single or double pole or a box-truss structure. The vertical columns are sometimes referred to as uprights, posts, or poles.

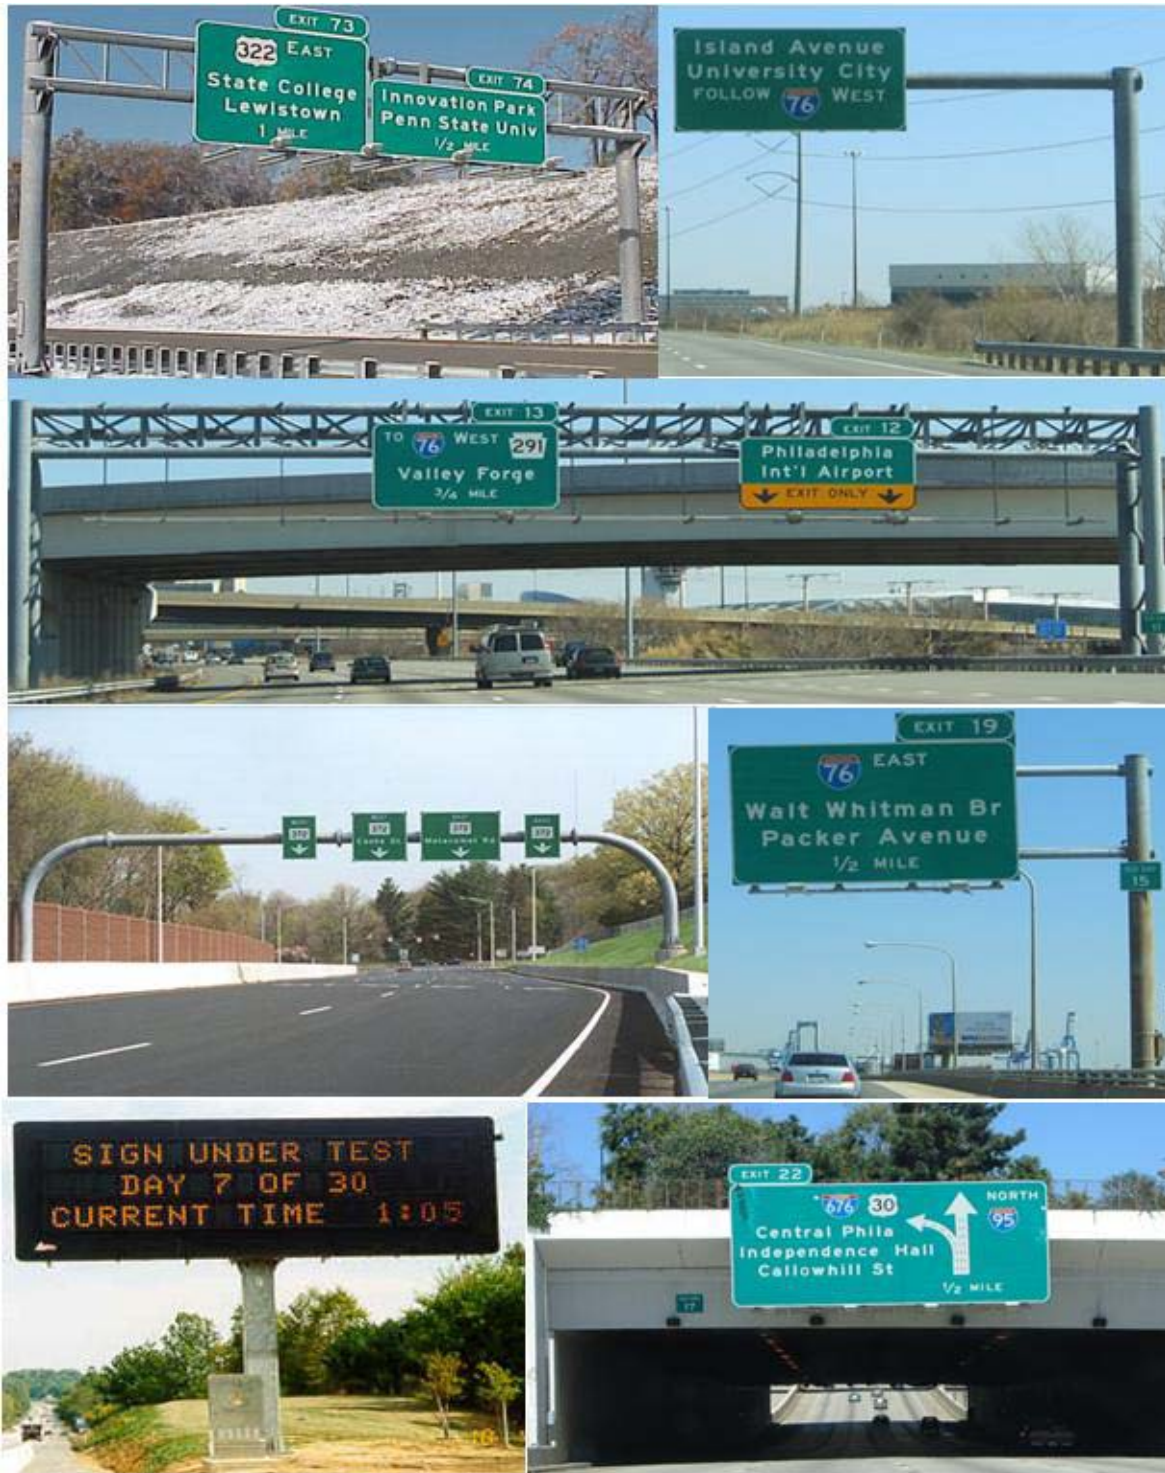
Figure 1.2 - Examples of sign support structures. Clockwise from top left: overhead truss with single pole supports, cantilevered single pole, overhead truss with truss supports, cantilever with double pole, a structure mounted sign, pole mounted VMS, monotube structure.

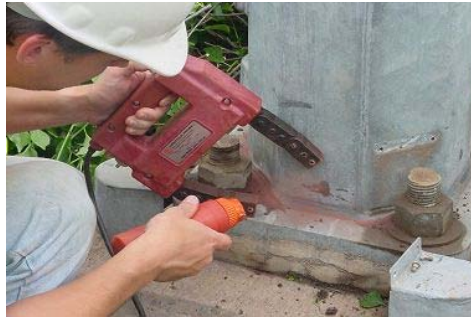
Figure 2.2 - Magnetic particle testing of a welded area.
(Source : <http://www.fhwa.dot.gov/BRIDGE/signinspection03.cfm>)

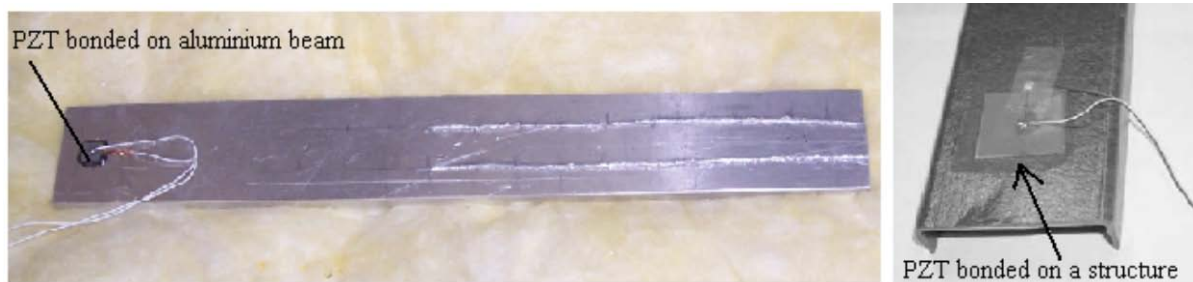
Figure 2.5 - PZT bonded on aluminum and steel beams.

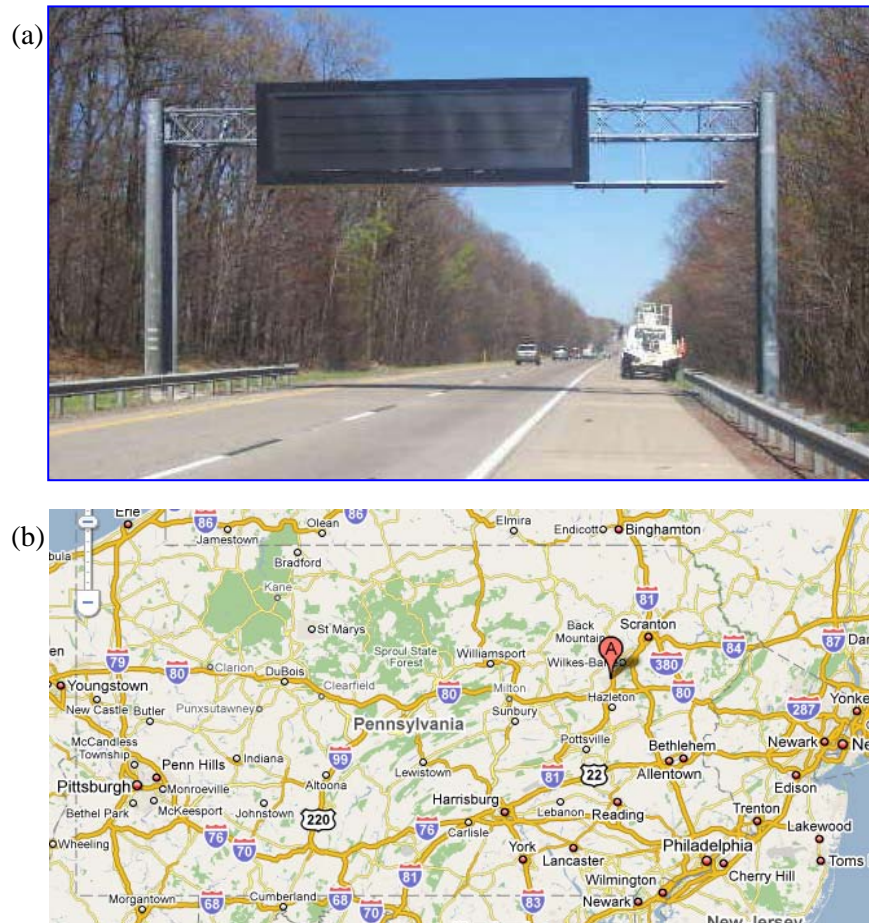
Figure 3.1 – (a) Photo of the sign support structure when in service; (b) Original location

One real-size sign support structure was tested at the University of Pittsburgh. The structure was part of a variable message sign support structure located over I-80 Eastbound, one mile West of the junction with I-81 in Pennsylvania, USA in Penn DOT District 4-0. The truss information was specified in Appendix A. A photo of the structure in service is shown in Fig. 3.1 while its location is illustrated in Fig. 3.1 (b).

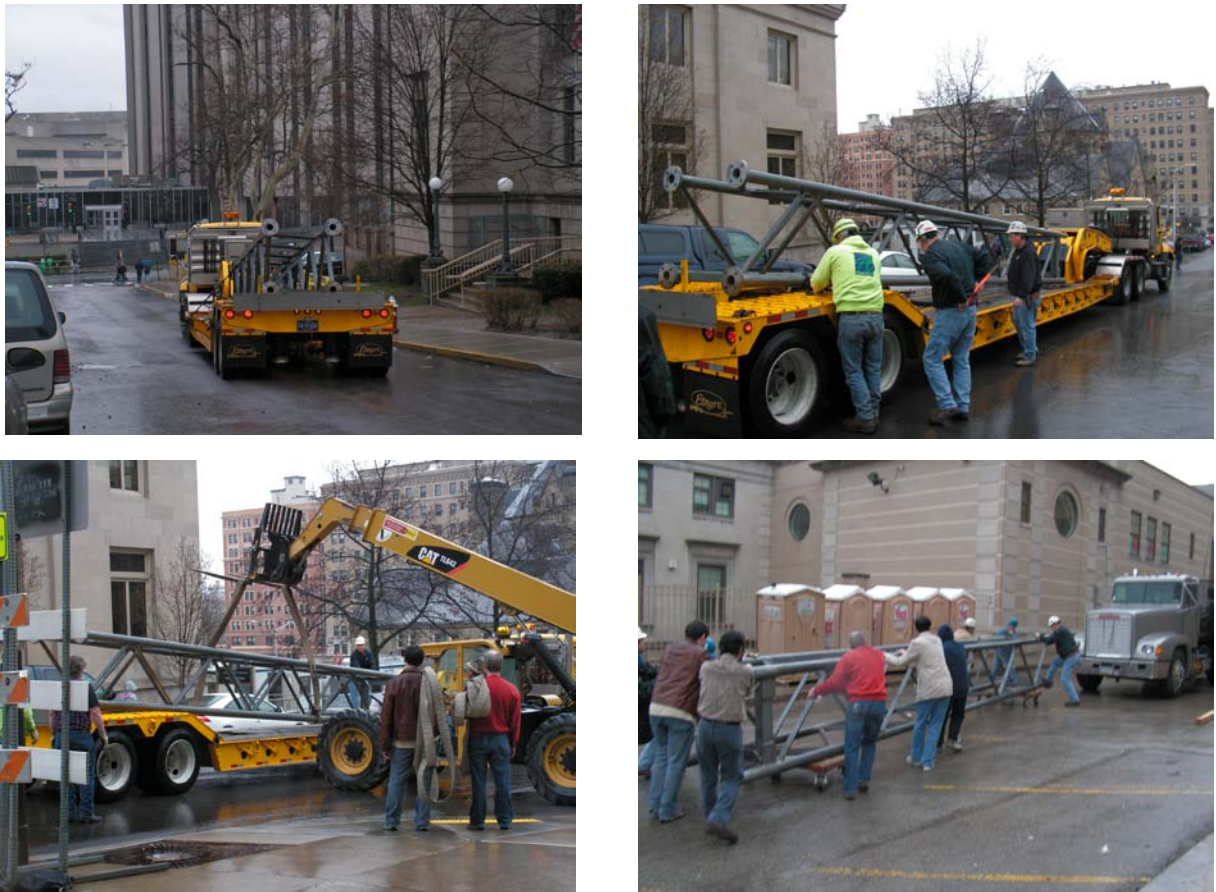
Figure 3.3 - Photo of the delivery at the University of Pittsburgh.

One of the two trusses connected with bolts in the original structure was delivered at the University of Pittsburgh. Photos of the delivery are presented in Fig. 3.3.

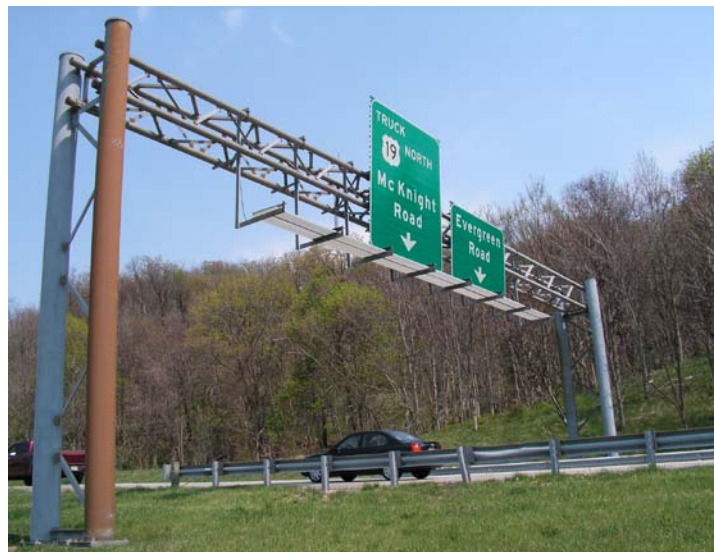
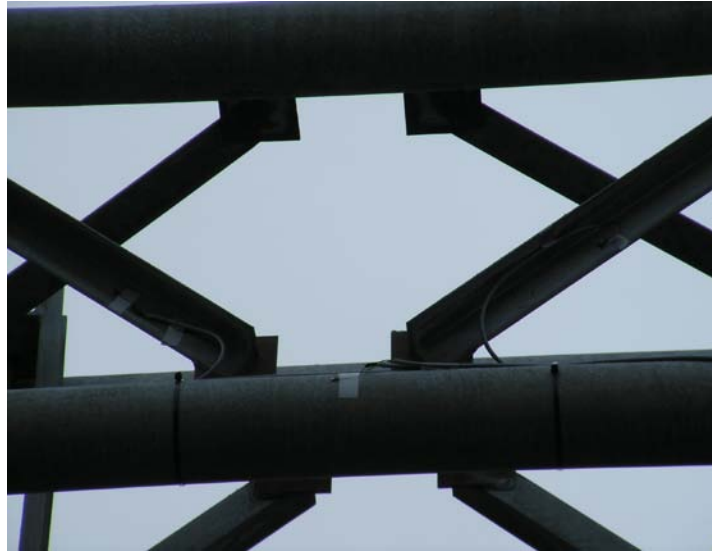
Figure 6.1 – (a) Photo of the structure monitored in the field. (b) particular of the welded connections

The first series of field test was performed on the sign support structure shown in Fig. 6.1 (a). The structure is located along the Mc Knight Road ramp of Interstate 279 (40.49153,-80.009442) few miles north of downtown Pittsburgh. The structure is denoted as L.R.1021 3-C and its information was specified in Appendix B. The main chords consist of tubular elements having HSS 6.625x0.432. Diagonal angular members (ST 2.0x3.850) were welded to the structure. A zoom in view of one of these welded connections is shown in Fig. 6.1 (b).

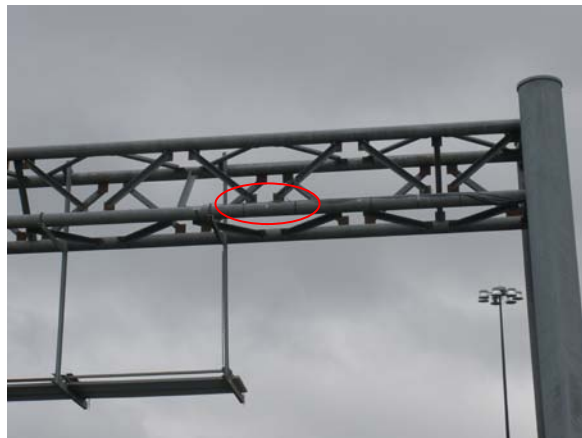
Figure 6.2 (a) Photo of the structure. (b) Close-up view of the part that was monitored. (c) Location of the sensing system. The red circles and arrow show the joints involved in the field test. Distances are expressed in mm.

The sensing system was deployed along the bottom chord on the rear side with respect to the traffic direction (Fig. 6.2 (a)). Eight PZTs were bonded to the structure along the part of the chord lying above the shoulder (Fig. 6.2 (b)). The choice of the sensors' location was such that during the installation the closure of traffic lanes was not necessary. Six PZTs in shear modes were used for the generation and detection of UGW.

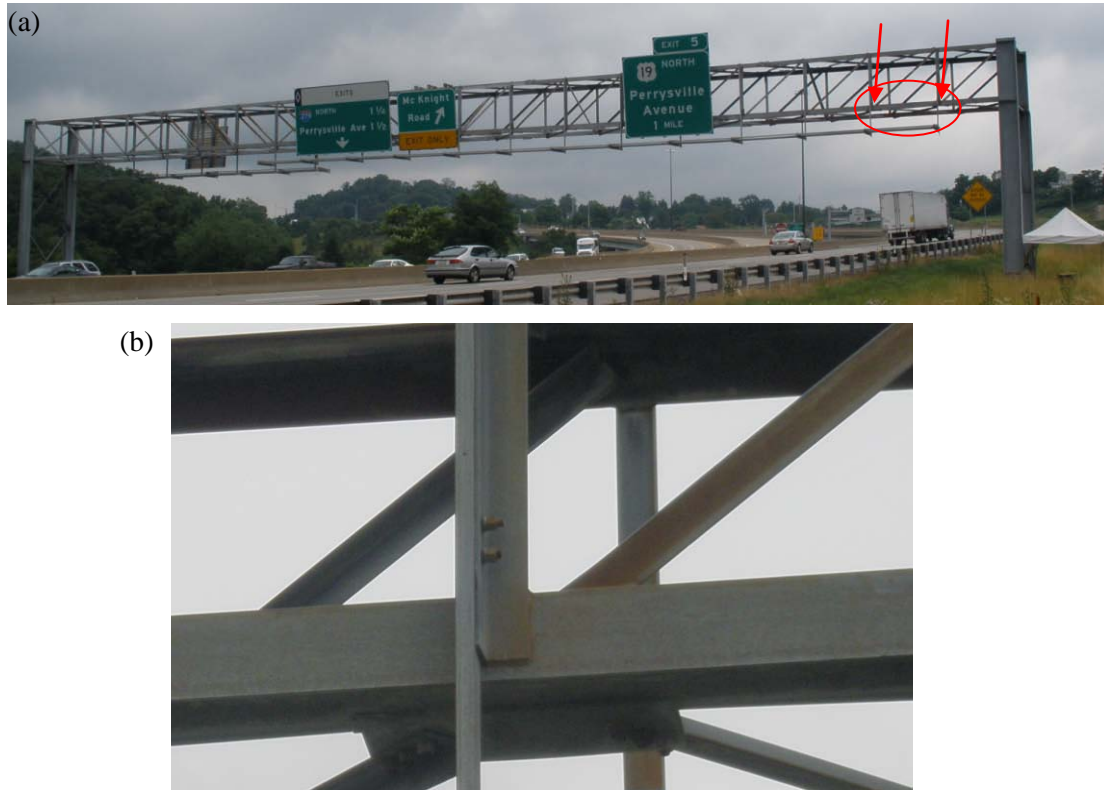
Figure 6.13 – (a) Photo of the structure monitored in the field, the red circle and arrows show the joints involved in this experiment. (b) Particular of the welded connections

The second field test was performed on the sign support structure shown in Fig. 6.13 (a). The structure is located along Interstate 279 at the same location of the structure described in the previous section. The truss information was specified in Appendix C. The truss consists of angular members. The diagonal members are bolted and welded to the main chord as shown in Fig. 6.13 (b).

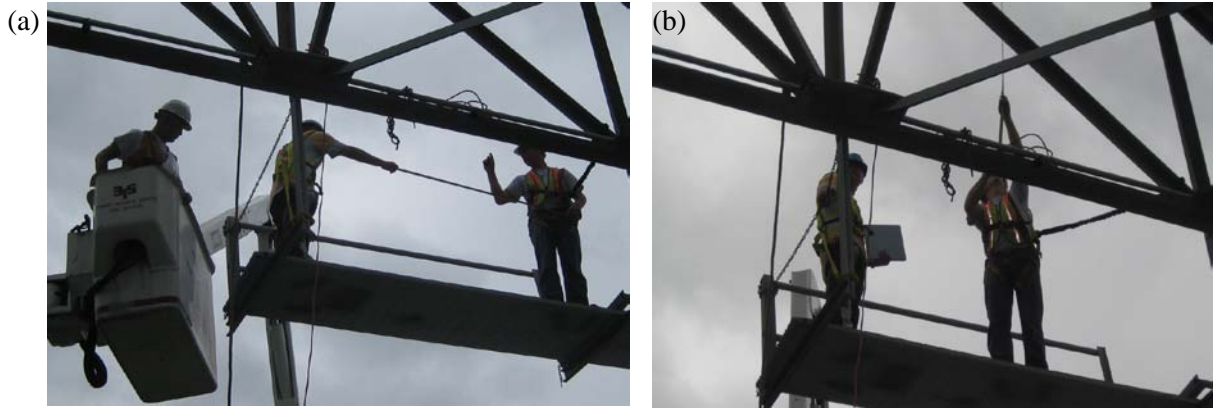
Figure 6.15 - Field testing: (a) Set up the safety rope. (b) Measuring the geometry of the trusses.

For this test it was decided to monitor the structure every fifteen minutes and to use the propagation of guided waves as a means for SHM. Phases of the installation are shown in Fig. 6.15.
